Test Report No.: **300.161/k-e** Date: **2003-05-07**

**PMMA-sheets PLEXIGLAS SOUNDSTOP® GS CC:  
Impact testing according to prEN 1794-2:2002**

**Test item:** PMMA-sheets PLEXIGLAS SOUNDSTOP® GS CC for  
transparent road traffic noise reducing walls, type 15/3500

**Specification of test:** Impact test according to prEN 1794-2:2002; Annex B

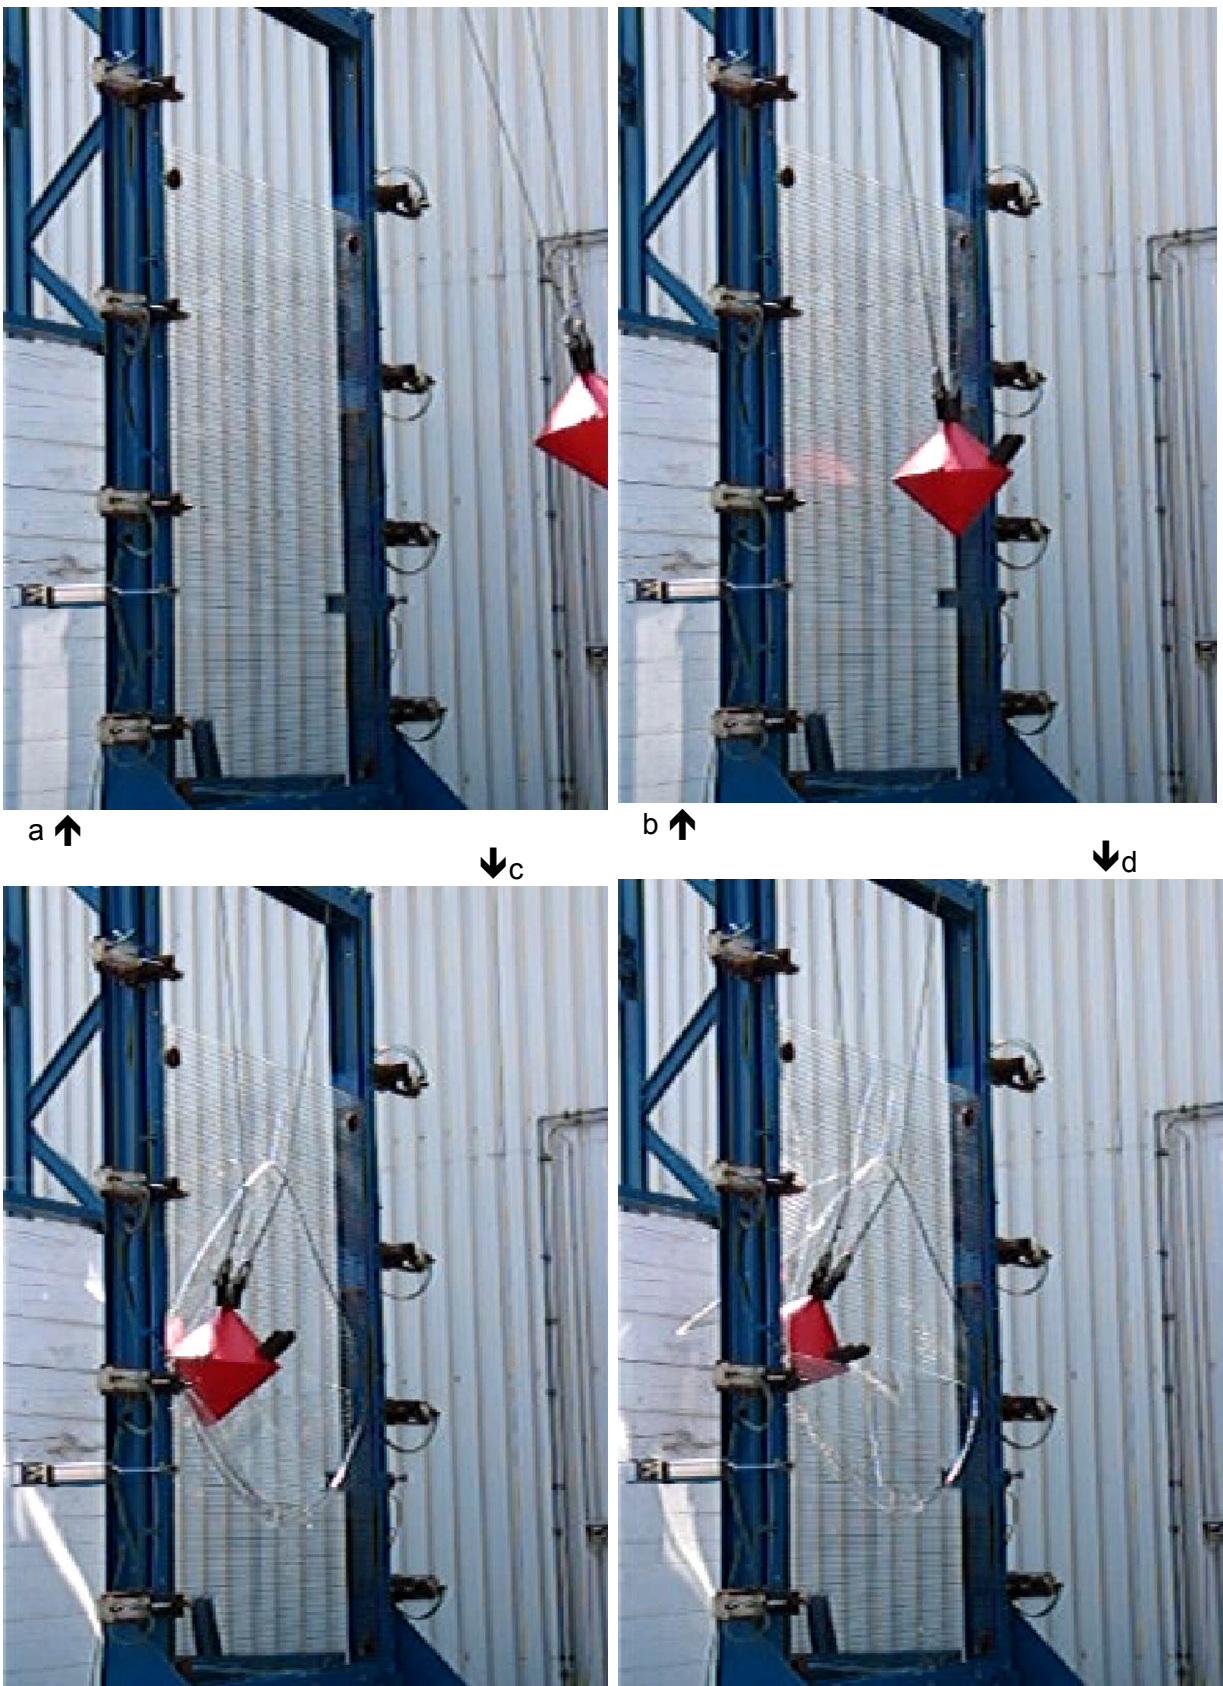
**Fig. 3:** Impact of the steel, double-cone impactor (cut off form the film sequence a → d)

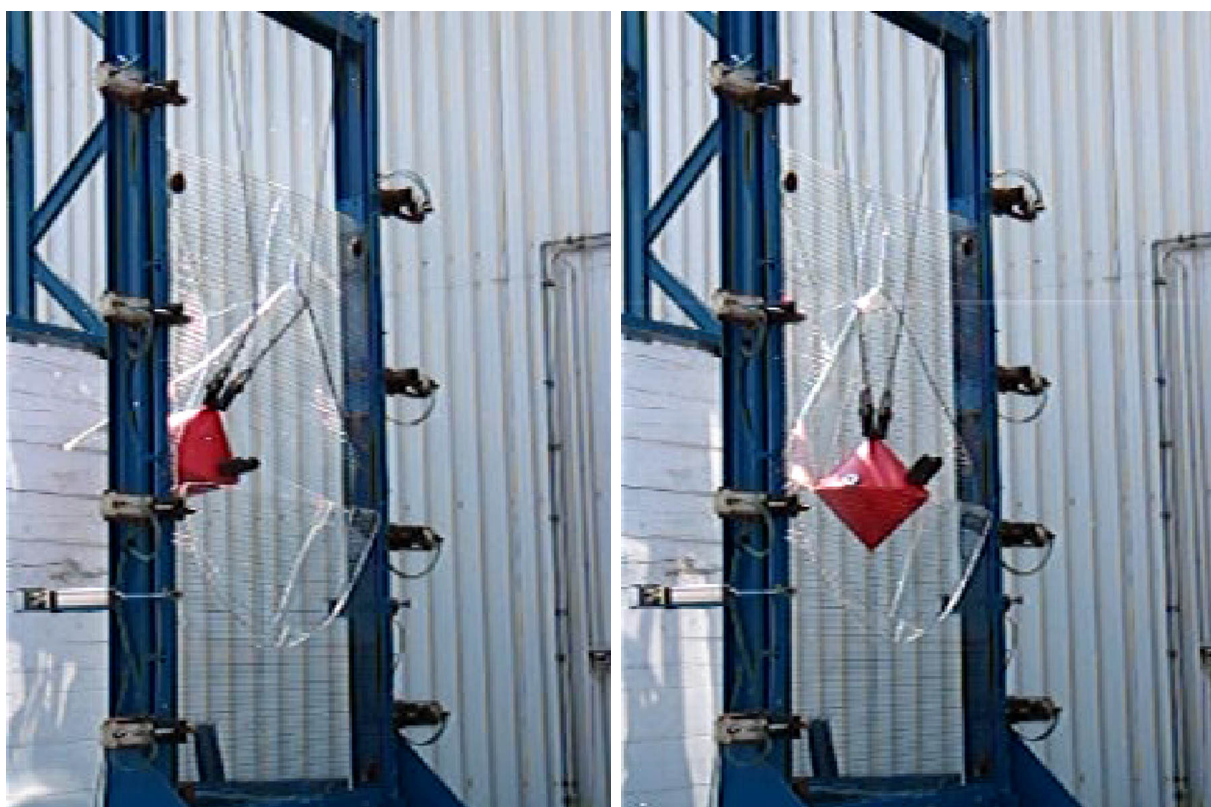
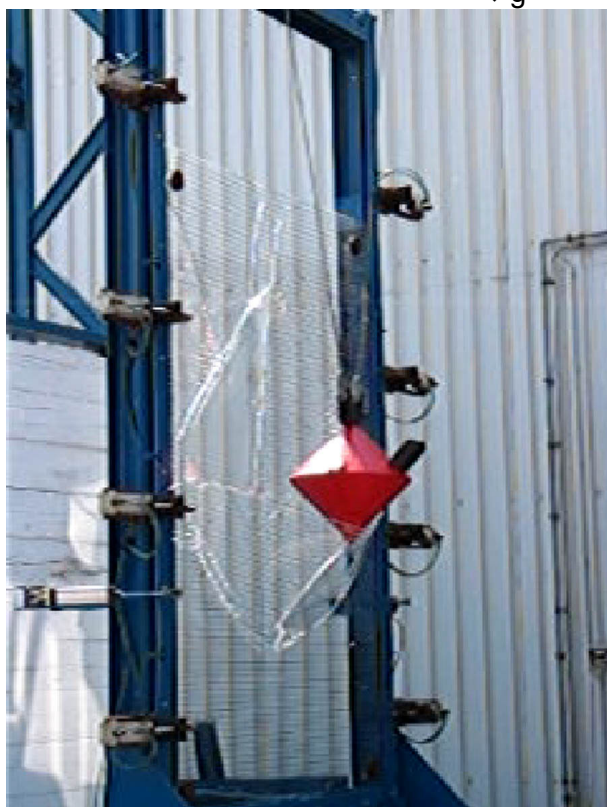
**Fig. 4:**  
Impact of the steel double-cone  
impactor and the backswing of the  
pendulum (cut off from the video  
film sequence e → g)

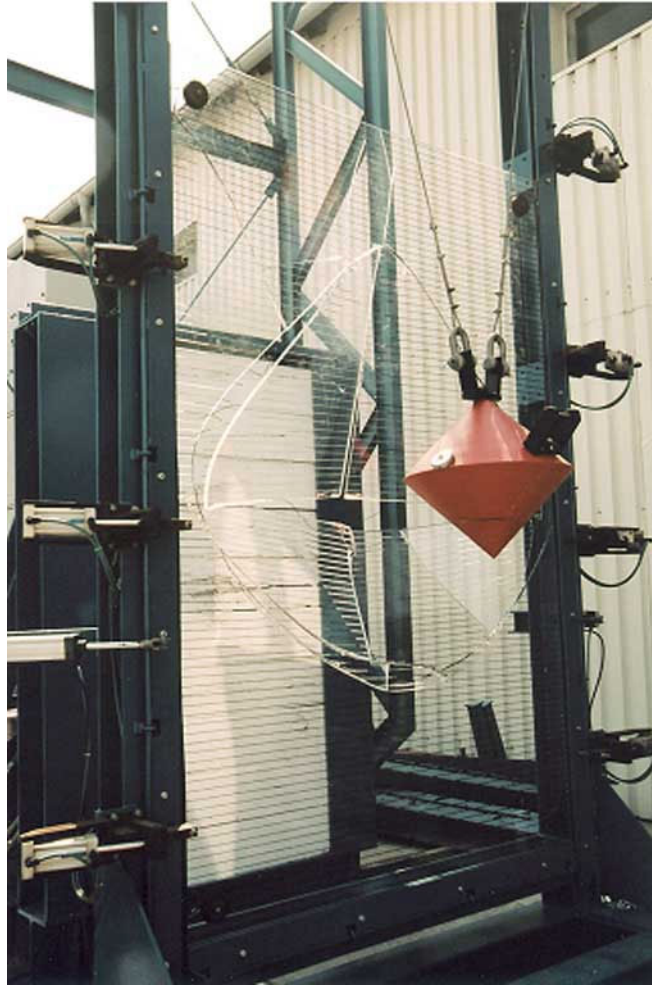
As documented in Fig. 3 to Fig. 8, the impact destroyed the test specimen but it **did not produce any loose fragments** that were

**Fig. 7:** Condition of the broken specimen after the impact test (no loose, large, sharp and heavy fragments were produced)

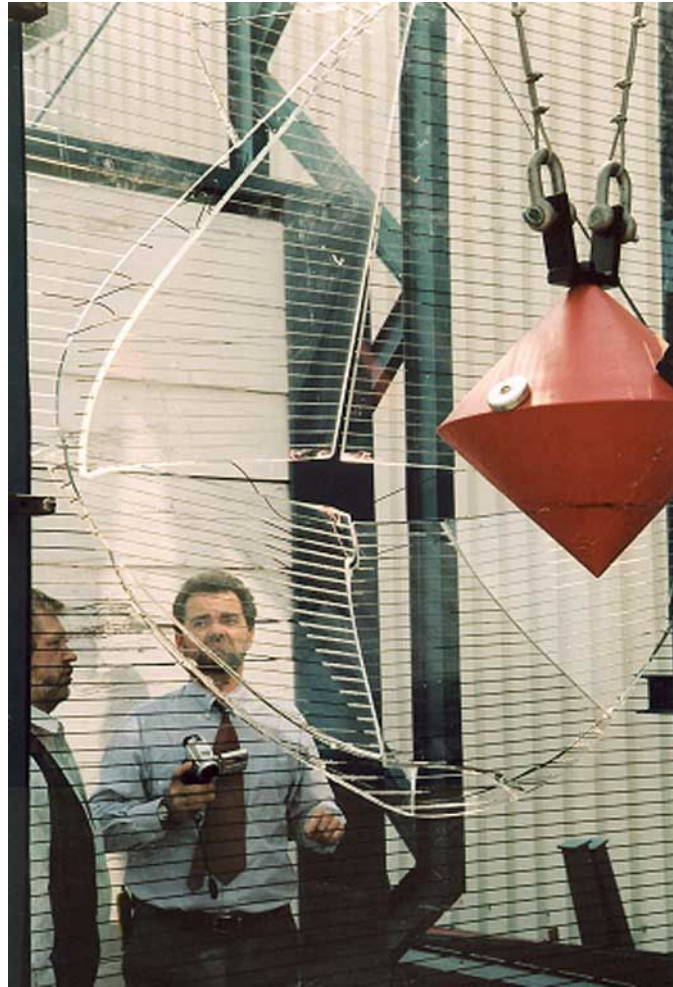
**Fig. 8:** Assessment of the broken specimen; all fragments are hold in place by PA-filaments
