Test Report No.: **300.161/k-e** Date: **2003-05-07**

**PMMA-sheets PLEXIGLAS SOUNDSTOP® GS CC:  
Impact testing according to prEN 1794-2:2002**

**Test item:** PMMA-sheets PLEXIGLAS SOUNDSTOP® GS CC for  
transparent road traffic noise reducing walls, type 15/3500

**Specification of test:** Impact test according to prEN 1794-2:2002; Annex B

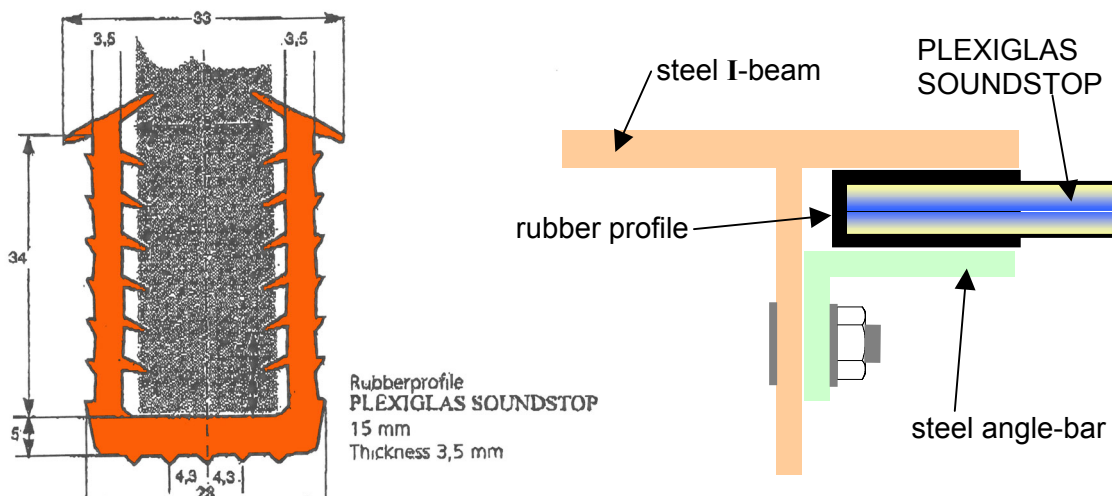
At the beginning of the test, the testing sample was fixed in a holding frame of the testing facility in the same way as in the use, i.e., clamped on three sides (together with special rubber stripes used in the standard holding systems) between steel profiles. To be protected from tear out from the holding frame, the specimen was additionally attached to the frame by steel cable loops in all four sheet corners. This is also a standard measure in the practical use. For details of the clamping geometry see the drawing in Fig. 1 and Fig. 2.

**Fig. 1:** Dimensions of the rubber profile and schematic drawing of the clamping system

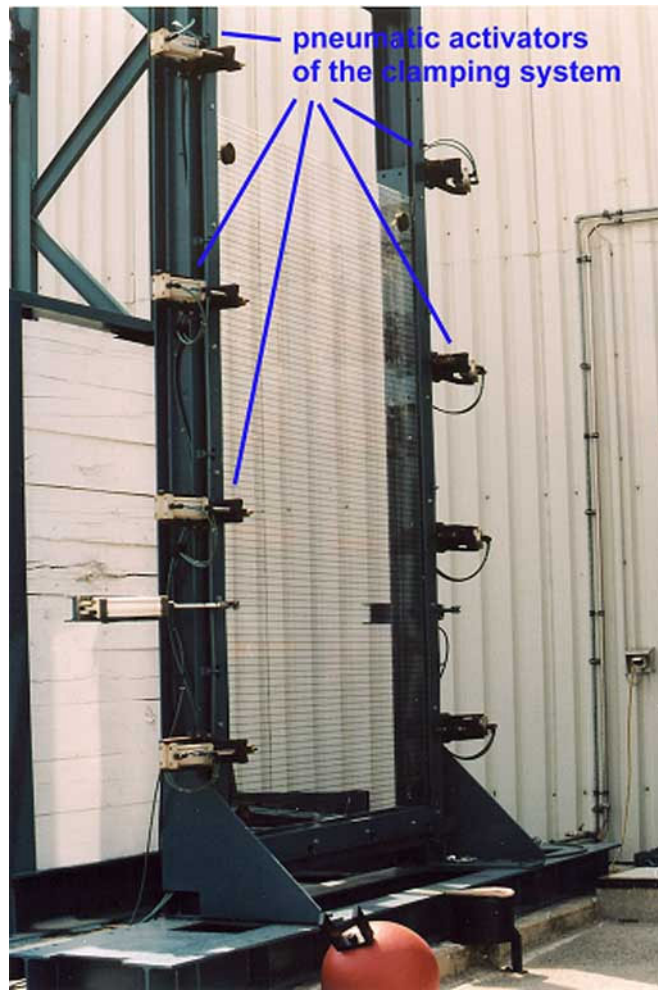
The upper side of the sheet was free as can be seen in Fig. 2. For the test, the specimen was positioned so that the PA filaments were horizontally oriented. The test parameters are listed below. The test run was documented by means of a digital video camera and by photographs (prior and after impact of the impact mass) which are reproduced below (Fig. 3 to Fig. 8); Fig. 3 to Fig 5 are cut off from the digital video film.

**Fig. 2:** Holding frame with the test specimen prepared for the impact test

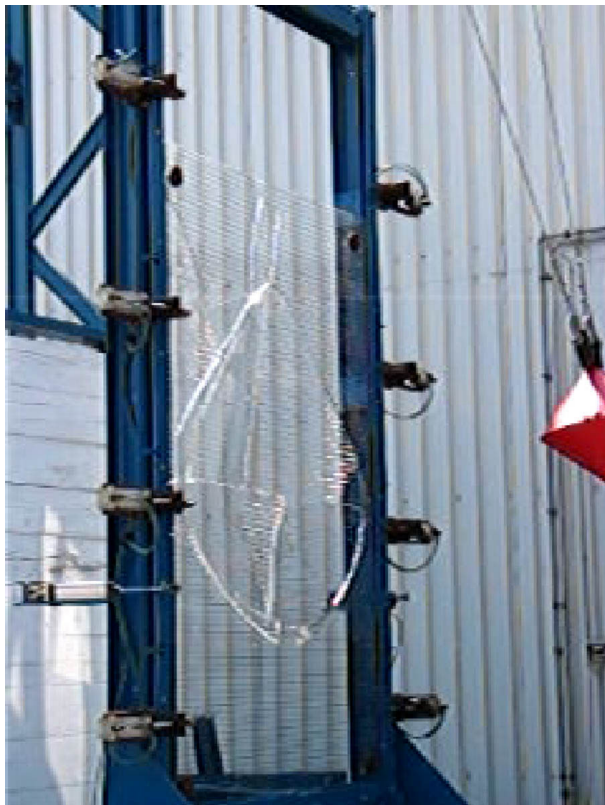
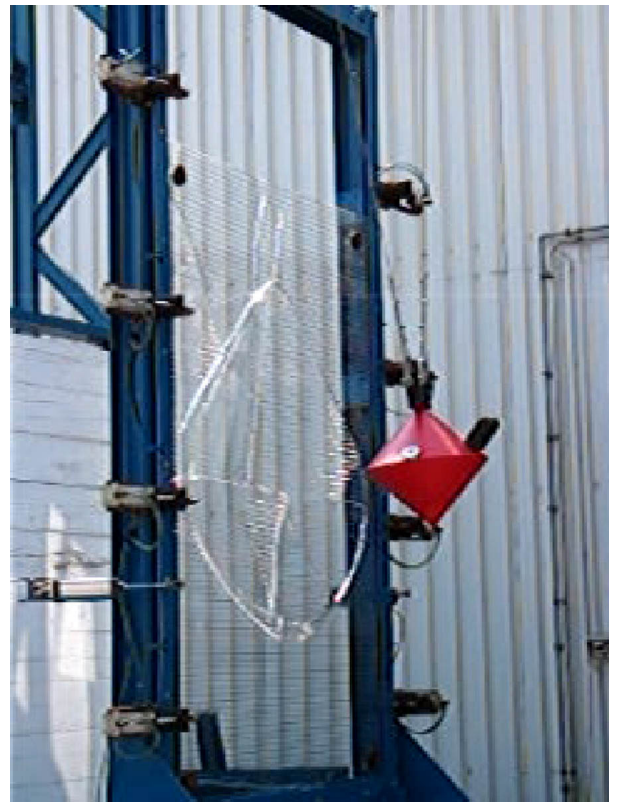
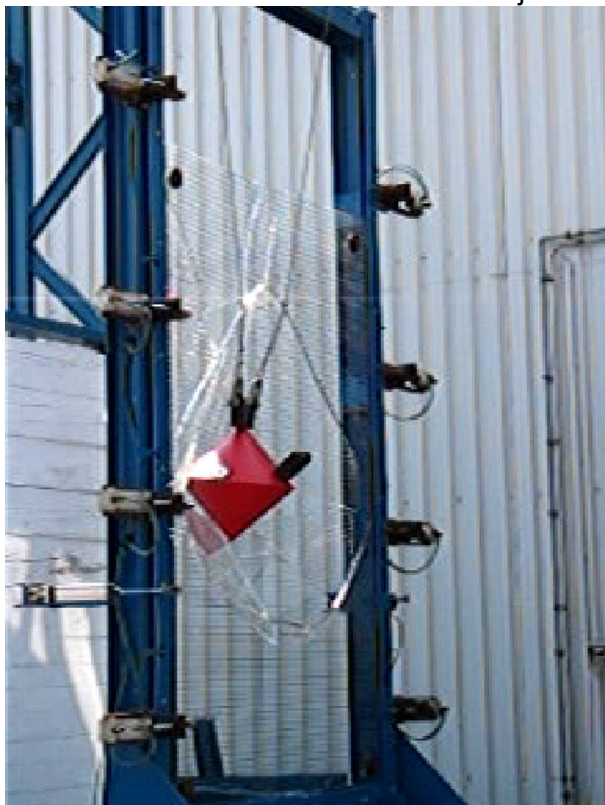
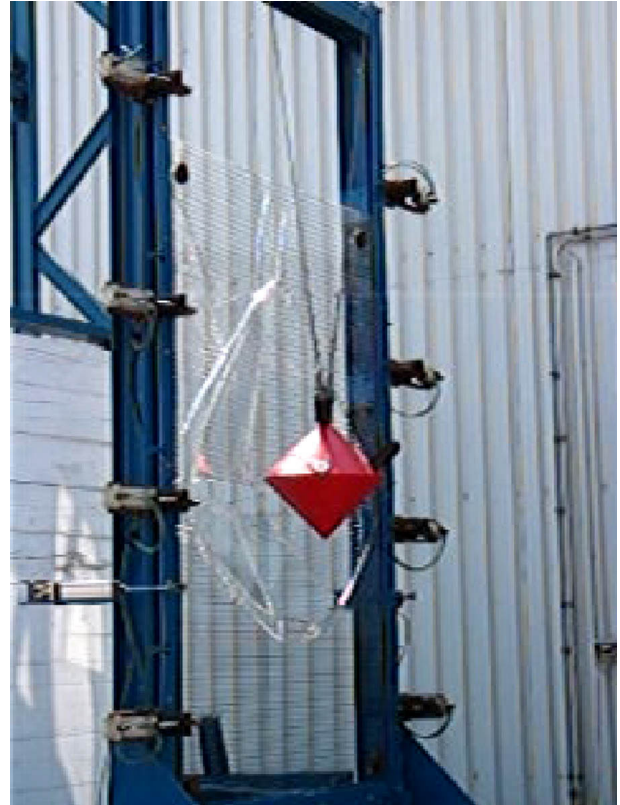
As documented in Fig. 3 to Fig. 8, the impact destroyed the test specimen but it **did not produce any loose fragments** that were

- a) heavier than 100 g and at the same time
  - larger than 25 cm<sup>2</sup>
  - or had edge angles smaller than 15°
  - or were thinner than 1 mm
- b) or heavier than 400 g
- c) or longer than 15 cm

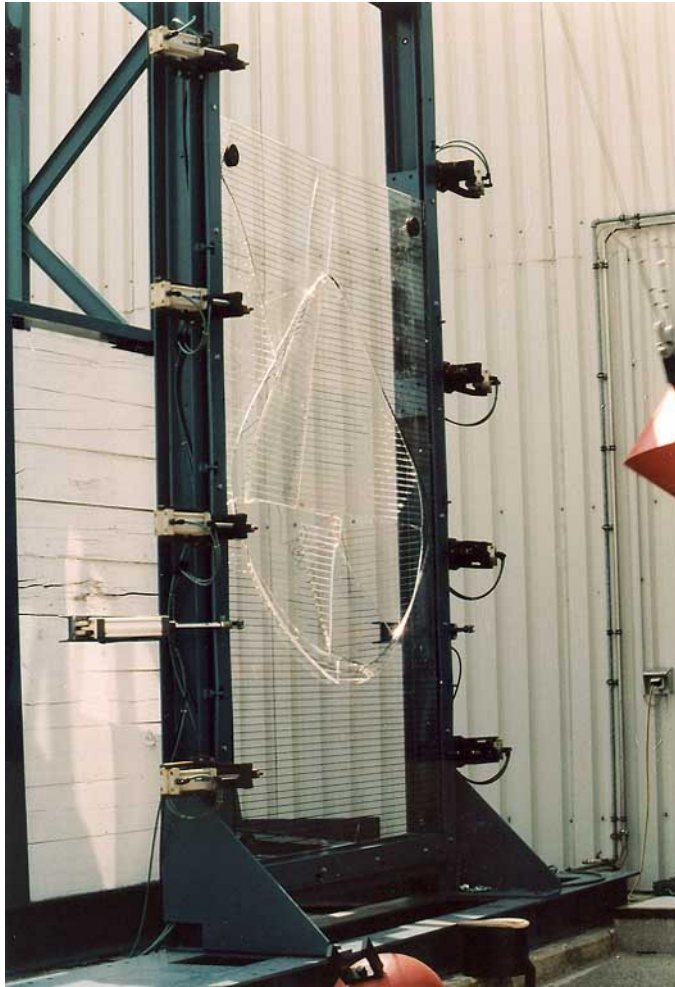
**Fig. 6:** Backswing of the pendulum after the first impact (photograph)
